Lower Duwamish Waterway Source Control Update (2010-2011 activities)

Seattle Public Utilities
May 3, 2012

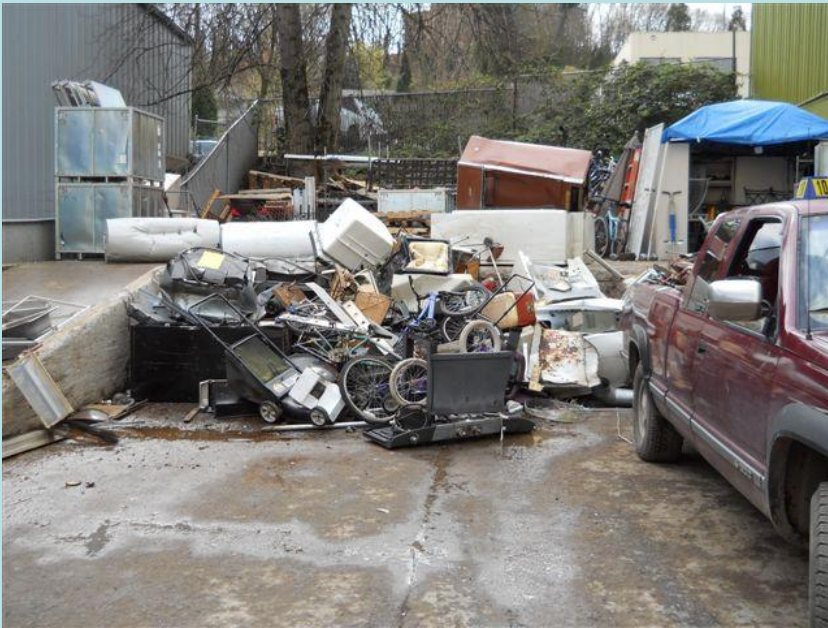
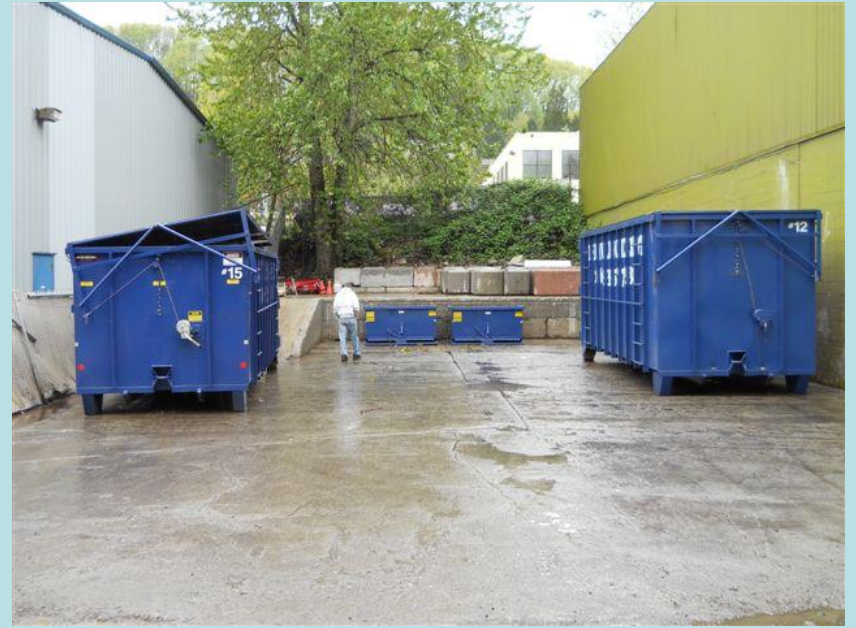
Corrective Actions

BEFORE

AFTER

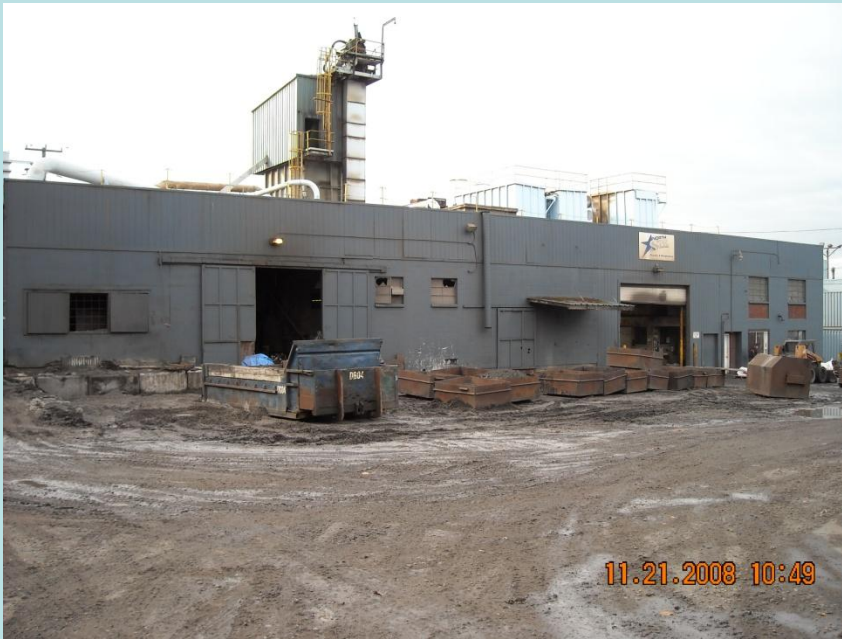
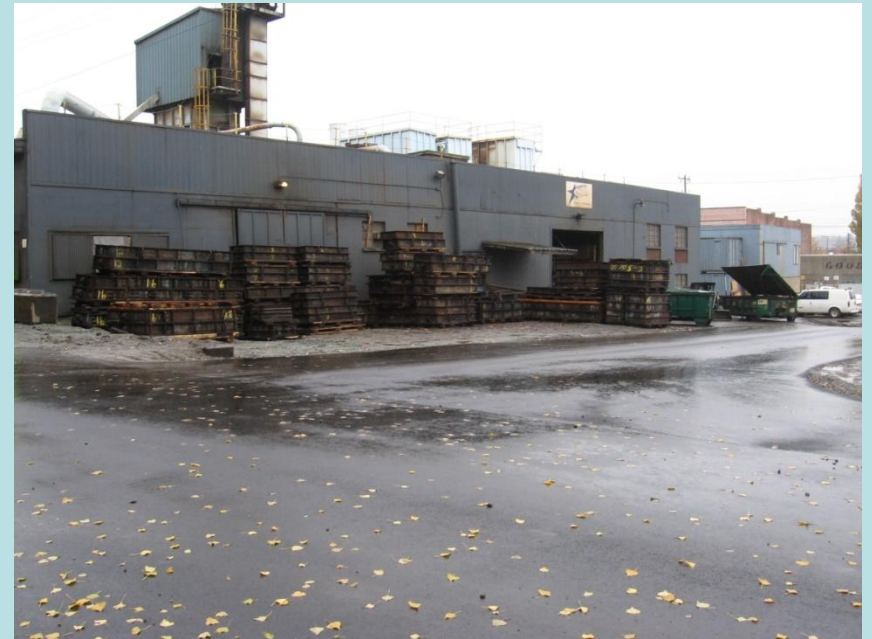
Corrective Actions

BEFORE

AFTER

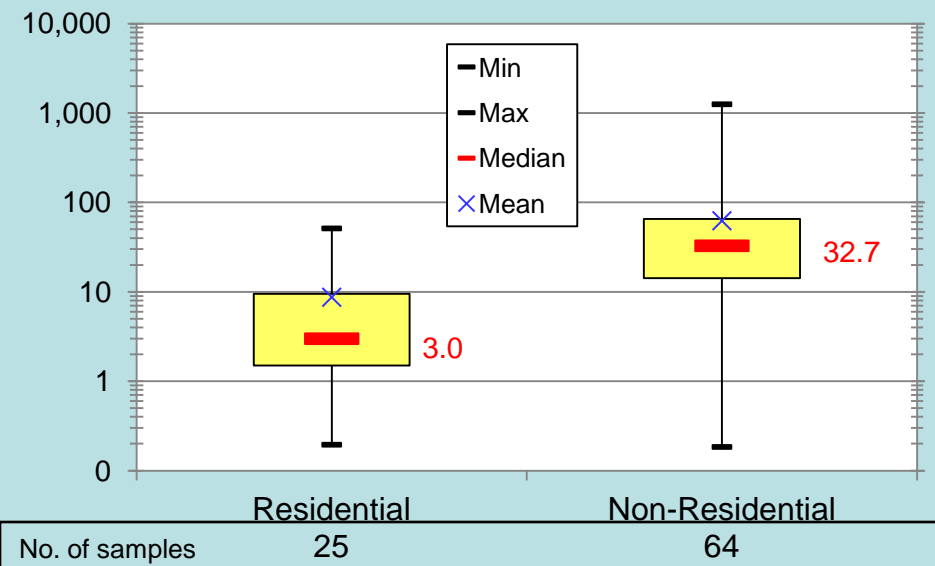
Source Samples: Compiled Dioxin Data

- TEQs generally lower in residential areas

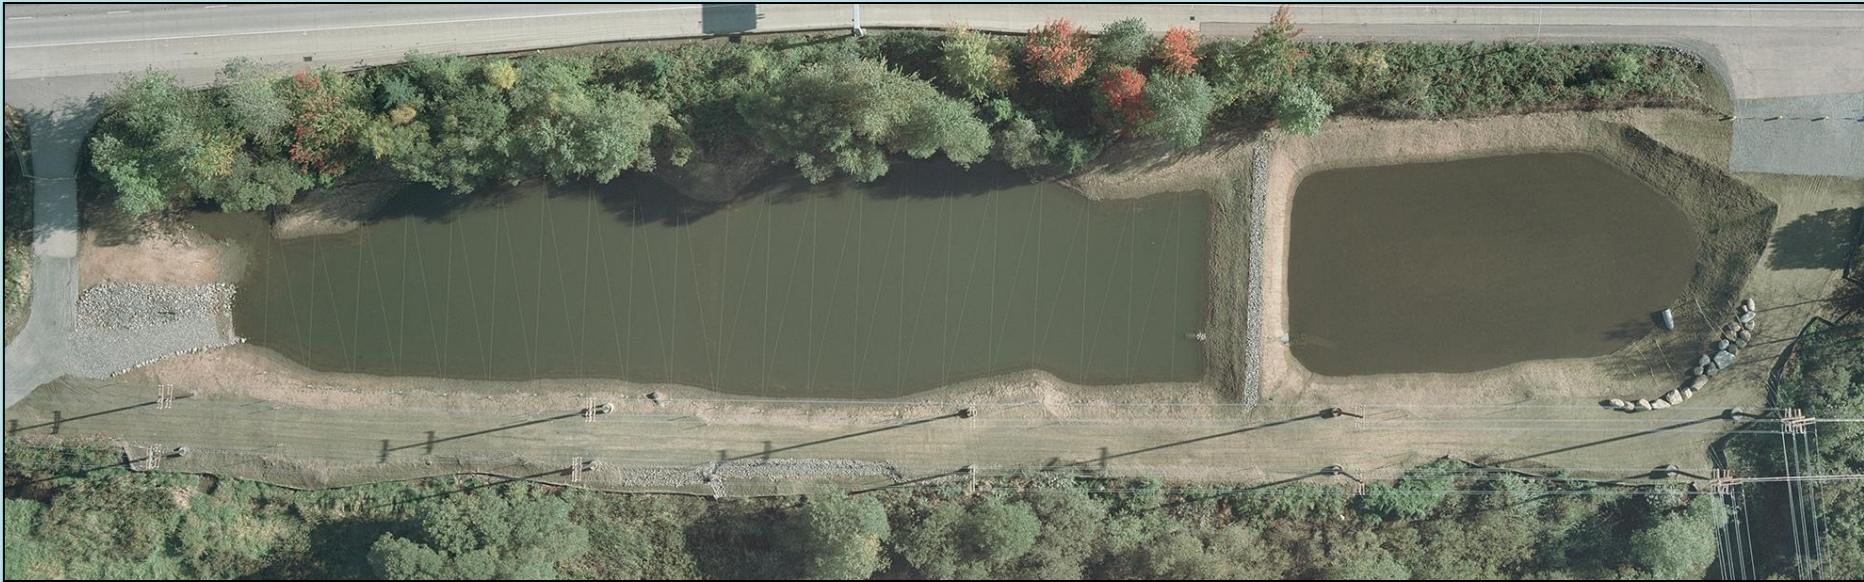
Norfolk/MLK stormwater pond

- 5 acre-foot wet pond/constructed wetland
- Treats runoff from 224 Ac
- Constructed 2011
